AERIAL THERMAL SCANNER DATA FOR MONITORING ROOFTOP TEMPERATURES

Remote Sensing Institute
South Dakota State University
Brookings, South Dakota 57006

Central Telephone and Utilities Corporation
CENGAS Division
Lincoln, Nebraska
November 1975

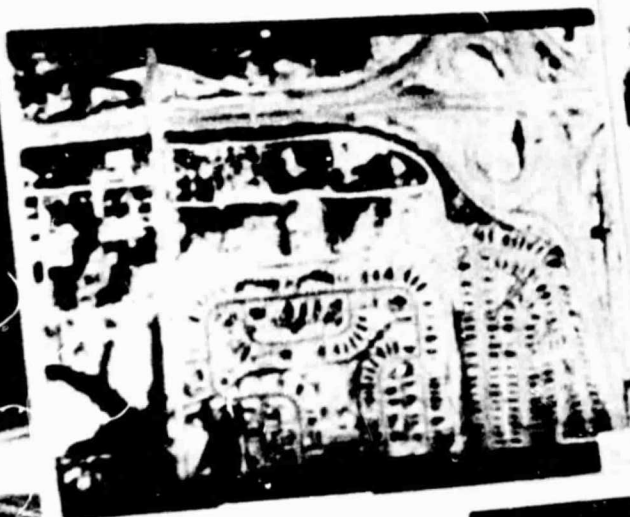
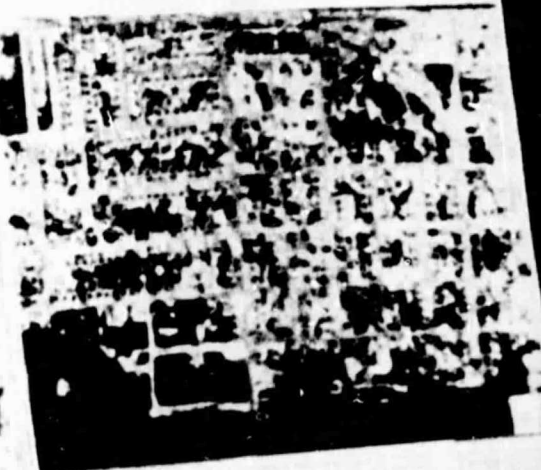
The aerial photograph shows the heat loss patterns of the house. These were
 obtained by using a computer with the Remote Sensing Center of the University of
 Nebraska-Lincoln. The computer is using satellite data obtained by the Remote Sensing Center
 of the University of Nebraska-Lincoln.

Figure 2. Portion of lobby display in CENGAS office at Lincoln, Nebraska.
